**Lehigh Southwest Cement Company**

**Subject:** Re: NOTICE OF VIOLATION and required corrective action for failure to protect stormwater at industrial facility

**Facility:** Lehigh Southwest Cement Co. (formerly Hanson Permanente Cement)  
Industrial facility, located at 24001 Stevens Creek Boulevard, Cupertino,  
Santa Clara County  
WDID No. 2 4310062677

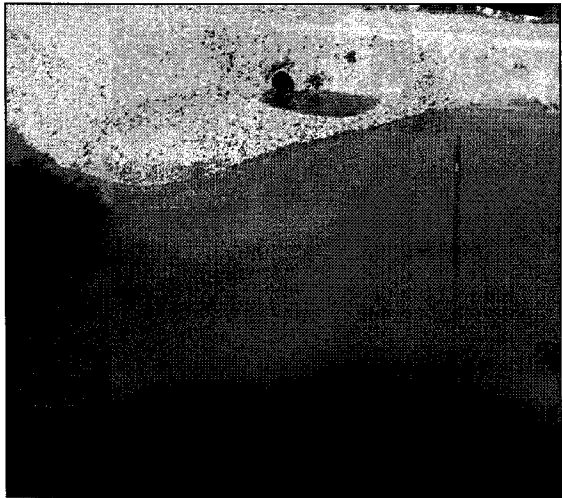
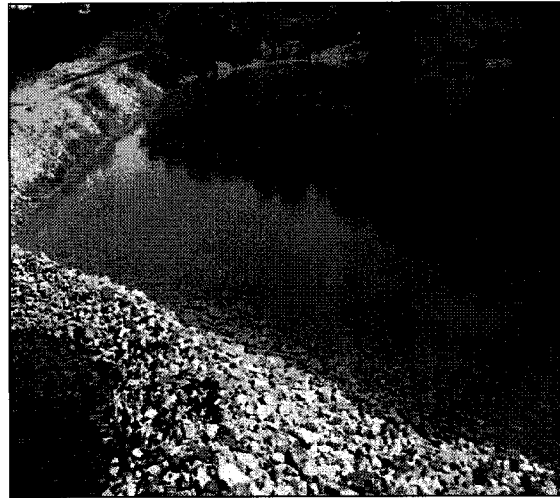
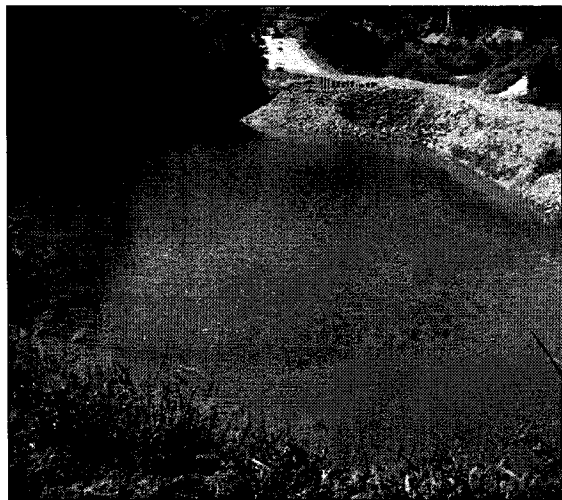
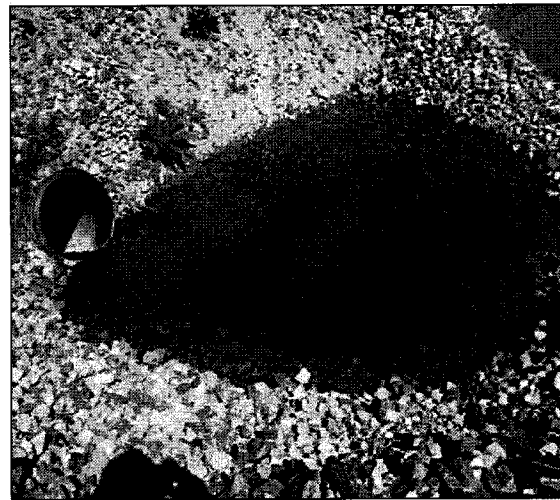
Pond 17 was completely cleaned out with the sediment removed and, as a function of stormwater quality, currently produces a very clean discharge. Please see the pictures below, reflecting post-cleanout Pond 17 water quality.

Pond 17 was cleaned out in the 2009 dry season, consistent with past practice. The frequency and intensity of the storms in late January/early February 2010 led Pond 17 to be completely filled with sediment just prior to the February inspection. The February 10<sup>th</sup>, 2010 inspection occurred before any pond sediment removal activities could be completed after conditions allowed following the most recent storm. However, these pond sediment removal activities were initiated on February 16<sup>th</sup> and completed on February 19<sup>th</sup>, 2010. As is consistent with all pond sediment

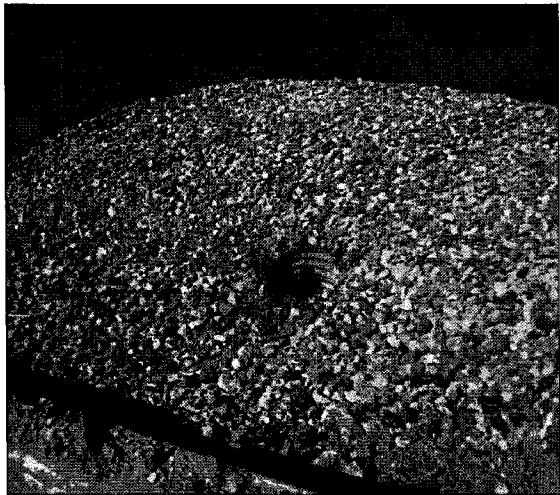
**Lehigh Response:** Pond 9 receives stormwater that come into contact with aggregate customer bulk trucks and plant mobile equipment. The pond is designed to retain this storm water allowing potential sediment to dropout before moving to the discharge standpipe. Additionally, the pond structures a limestone material around the discharge standpipe for further sediment control and water "polishing" prior to discharge. The recent frequency and intensity of the storms in late January / early February 2010 resulted in the inlet of Pond 9, only one of the five roadway inlets, to be filled with sediment. Pond 9 was inspected late in January and, at that time, was holding up well. At the time of the inspection the pond still retained retention capacity to allow for sediment dropout. However, it was noted that the limestone filter material had fallen away during the most recent storms prior to the February 10<sup>th</sup>, 2010 inspection.

Because of contractor scheduling delays and storm events the scheduled Pond 9 clean out will be carried out the week of April 19, 2010.

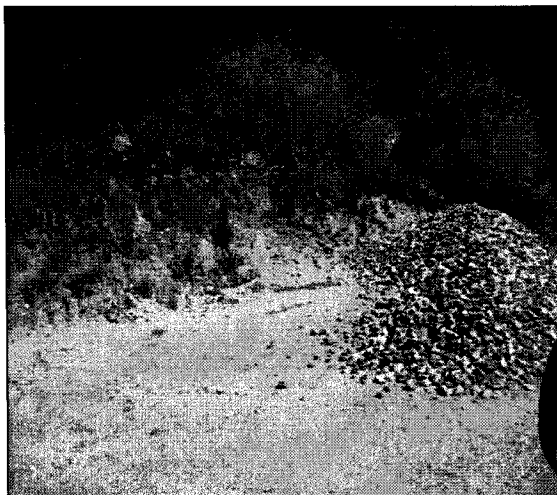
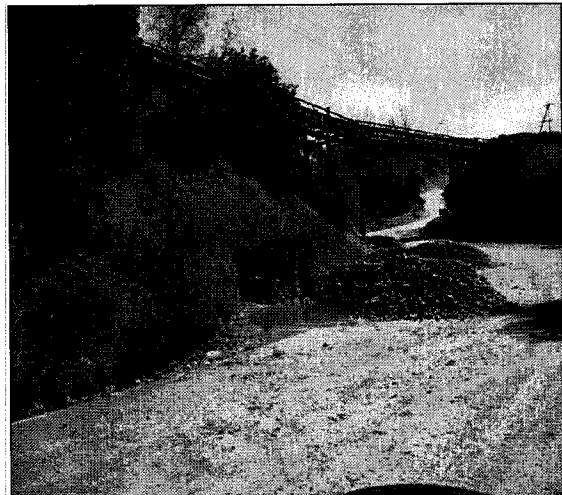
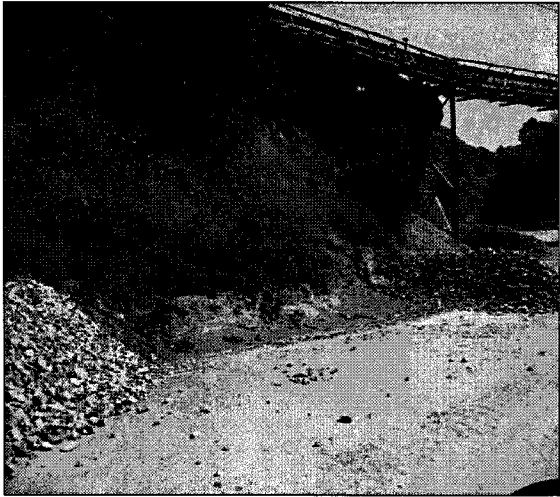
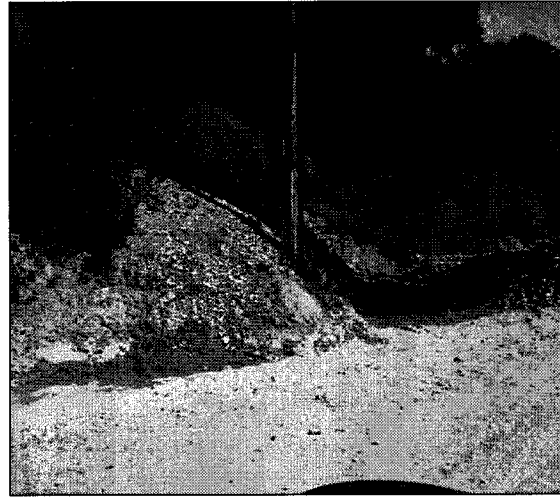
**Lehigh Response:** The unpaved road referenced in the inspector's report, Lower Quarry Plant Road, has a series of catchment bays, or sediment traps, on the inclined portion side on the road.

These “trap” bays have been very successful in capturing sediment-laden stormwater along this area. The inspector noted that the “trap” bays had not been maintained. The fact is that these traps are cleaned out and re-established during the dry season. During the wet season, these bays are cleaned out in between storm events, when water has subsided to the extent that cleanout activities do not subject the area to “mud” drainage and / or spillage. The recent frequency and intensity of the storms in late January / early February 2010 did not allow for cleaning of these bays prior to the February 10, 2010 inspection. However, these bays were cleaned out of material on February 17, 2010, when the weather’s “break in the rain” had allowed for a minimal of mud disturbance. The bays are currently functional. It should be noted that the discharge from these bays go Pond 9 for further clarification / sediment fallout prior to discharge.

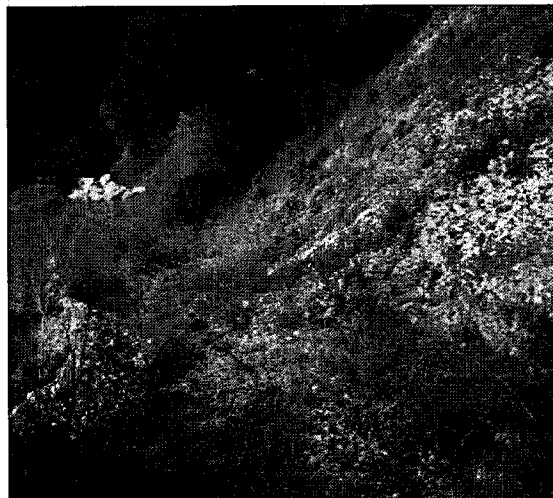
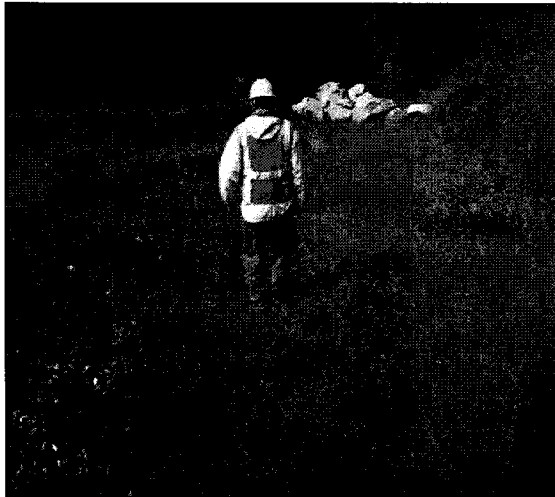
**Lehigh Response:** The "evidence of slope erosion and concentrated flow" noted by the inspector is in a historic disturbed portion of the hillside northwest of Pond 13b. The rocks show in photograph 31 and 32 of the inspection report are historic and are not indicative of any current erosion activity. Erosion is not indicated after the inspectors picture (Photo 30), and water flow does not carry sediment to pond 13, as would be evidences by non growth establishment and/or sediment channeling and accumulation. Additionally, the hillside above this area recently has been fairly successful in establishing groundcover growth established through repetitive hydro-seeding activities.

The observed corrugated damage above Pond 13b noted by the inspector was based on an occurrence that damaged the existing ½ corrugated channel that was in use in July of 2007. It was also brought to the attention of the inspector that the damaged ½ corrugated culvert had been abandoned after that occurrence; a new section comprised of full and ½ sections was immediately erected and now is used to divert upper quarry road stormwater around the hill-side to pond 13b. To clarify the record, during the inspection, the Environmental Manager did not note to the inspector that the conveyance was in need of repairs.

Lehigh believes that the inspector's/Board's claim in item 6 is incorrect and that additional BMPs and repairs are not needed in this location. Further attempts to work on this steep slope would risk disturbance of the recovering groundcover.

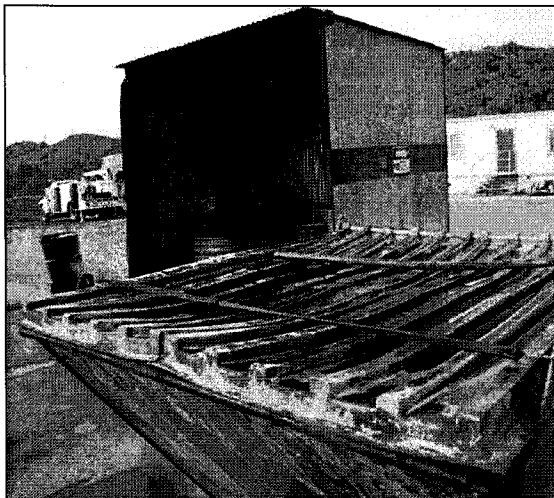
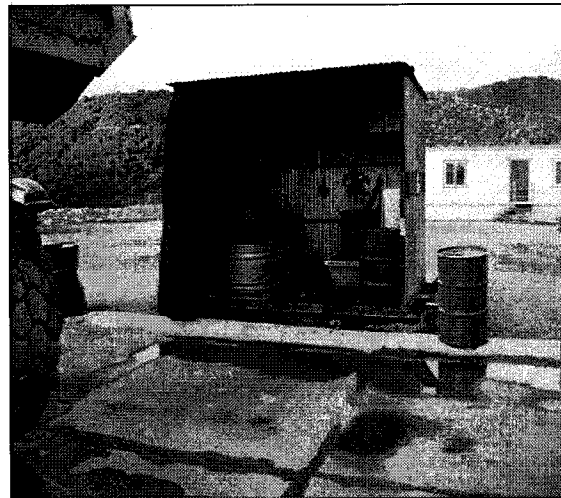
**Lehigh Response:** This area noted is the Upper Garage, located by the Quarry Office. The poured concrete pad is equipped with curbed sides to contain rainwater. The area is used for off-road mobile equipped maintenance and repair activities. The size of the equipment maintained makes the utilization of a covered roof unrealistic. The BMP implemented is to immediately contain, isolate and clean up any spilled lubrications or other contaminants that fall within the containment area. Additionally, all maintenance work in the containment area is limited during a storm event.

The petroleum based lubricants have been moved to a covered container stored outside of the noted containment area. The lubricant drums are stored in secondary containment within this container. Additionally, the noted waste container for oily rags has the covers affixed and in the closed position, and has been equipped with bungee cords to maintain cover closure. See photos below; note that the peripheral empty and clean blue barrels are utilized to cover ground level bolts, protecting mobile equipment tires from potential damage.
